Request for Proposal**Archeological Survey for 2020 GLO MIT City of Kenedy Water Improvements Project, Contract #22-085-006-D234**

2020 GLO MIT City of Kenedy
Water Improvements
GLO Contract No. 22-085-006-D234

Excerpt Pages from Archaeological Draft Report
for Remaining Areas to be
Surveyed and Monitored

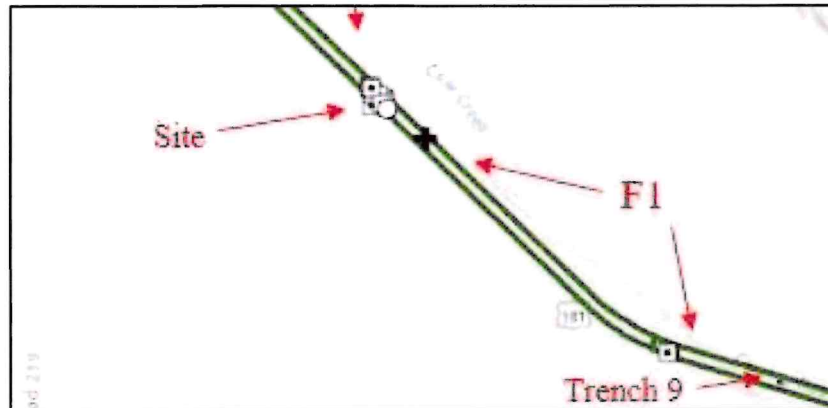
Figure 5-10. Map of Area F near Highway 181 & CR 222, Cow Creek.

Area F1 - A total of four trench units were planned for this area. In the area north of Trench 9, very dense and overgrown vegetation combined with a fence line left no access for the backhoe or movement north within the RR ROW.

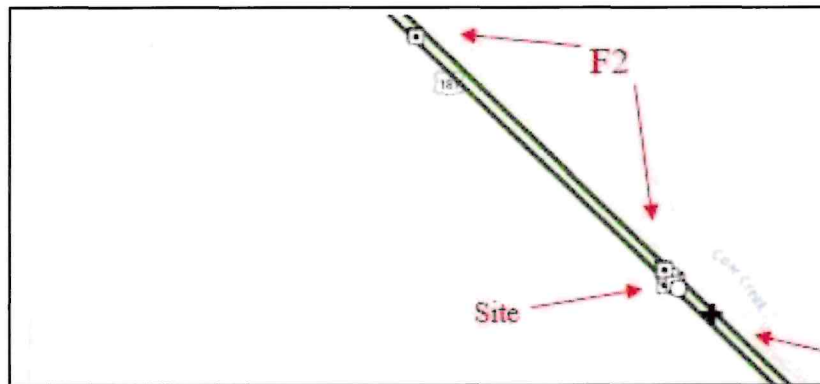
Figure 5-13. Map of Area F2, Highway 181.

Area F2 - A utility access easement north of F1 provided access to the ROW south of Cow Creek (Figure 5-13). Two planned trenches were excavated in this area, along with seven additional delineation trenches and a shovel test, resulting in a prehistoric site being recorded (41KA225), which is discussed in more detail in Section 7.2.1. The area north of the site was not accessible due to the dense vegetation north of Cow Creek and the RR grade buildup. In the northern portion of F2, a fence line is blocking entry from the north to the south, and there

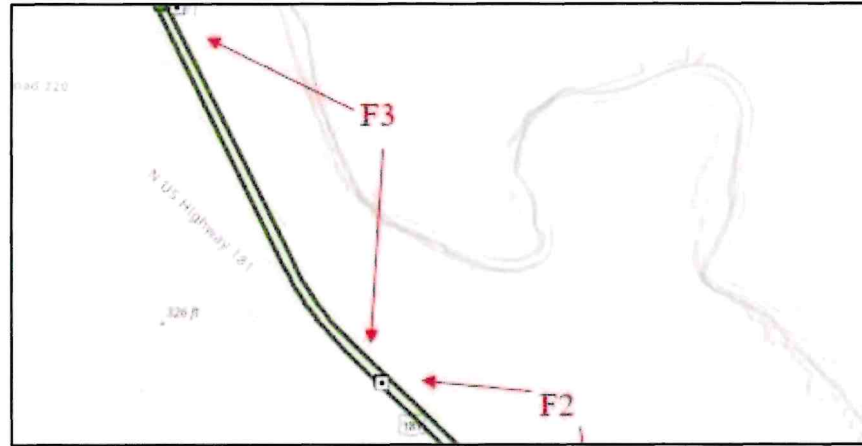
Figure 5-17. Map of Area F2, Highway 181.

Area F3 - A total of six trench units were pre-plotted for the area of F3 (Figure 5-17). This area was not accessible with the backhoe due to the same issues with F1–F2: dense vegetation, fence line, and unable to access the ROW in this area.

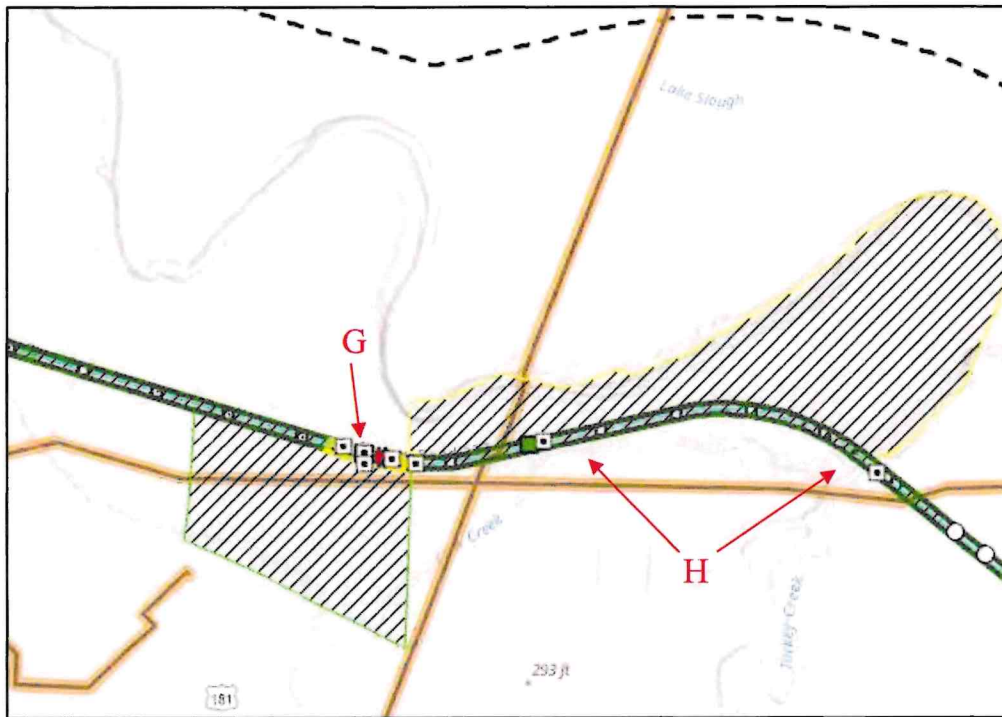
Figure 5-20. Map of Areas G and H, CR 222, Turkey Creek.

One trench was plotted for area G, however, an unverified gravesite or cemetery was reported by the landowners, so no subsurface testing was done in this area (Figure 5-20). The unverified gravesite is discussed in Section 7.1. In addition, Area H in the map was scheduled to be tested with four trench units, however, due to the RR grade buildup, heavy vegetation, and restrictions of the 30-m wide corridor, access was not possible with the backhoe (Figure 5-21).

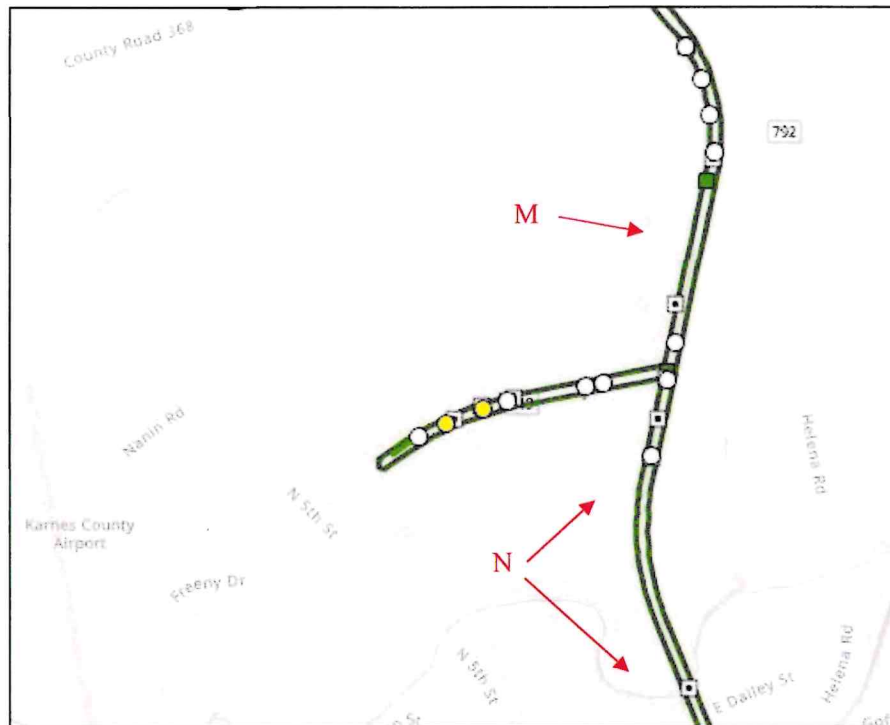
Figure 5-33. Map of Areas M and N near FM 719.

Two trenches were pre-plotted for Area M, north of FM 719, and two trenches were pre-plotted for Area N, south of FM 719 (Figure 5-33). These areas of the APE were not able to be tested due to the extreme RR ROW buildup (Figures 5-34 and 5-35), presumably to raise the tracks out of the floodplains. There was no feasible access for the backhoe operator, the buildup within the ROW that encompassed almost the full width left no areas to test.

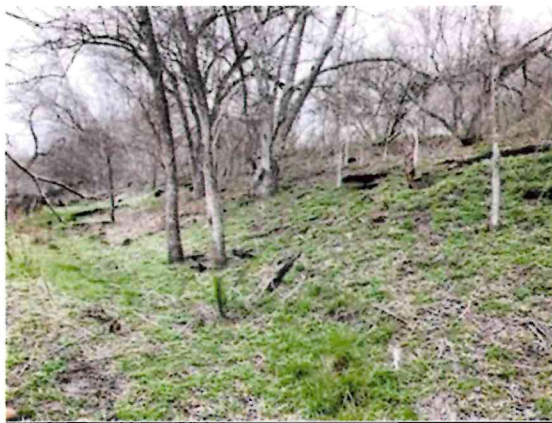
Figure 5-34. Area M north of 719 and the RR grade buildup and trees within the ROW looking north.

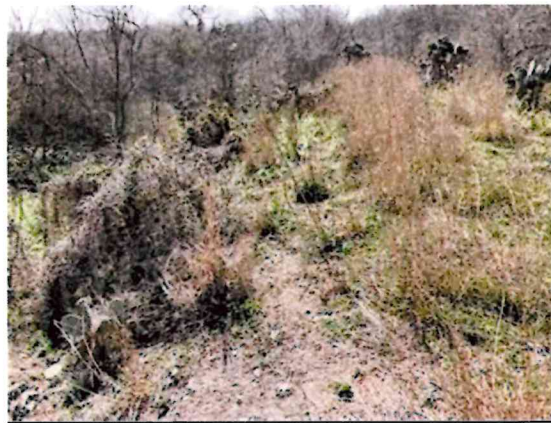
Figure 5-35. Area N, the extreme buildup of the RR grade south of FM 719 looking south towards the direction of Escondido Creek.

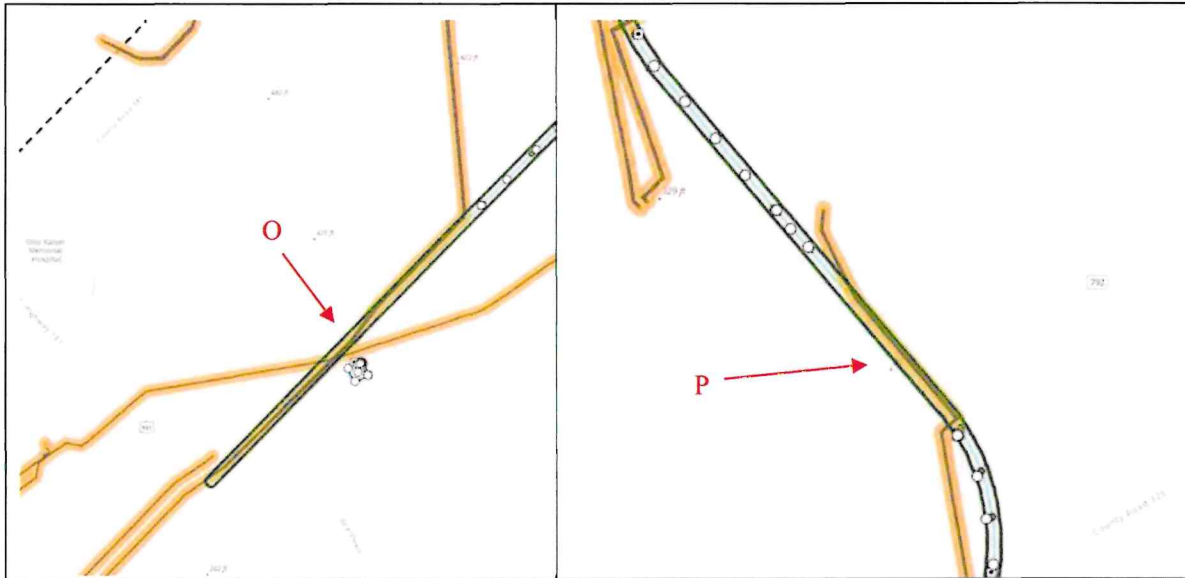
Figure 5-36. Pipeline conflicts within the APE.

Two areas of the proposed pipeline prevented shovel testing or trenching due to conflicts with the oil, gas, and/or water pipelines. In Figure 5-36, the yellow line represents the no-dig safety buffers around pipelines within the ROW. In the area of the elevated storage tank, Line B,

between CR 344 and HWY 181, several pipelines run parallel with the proposed water line (Area O below). The second area is approximately 990 m north of FM 719 and 347 m west of FM 792 (Area P below). The pipeline conflicts left no space to place any subsurface testing within the ROW. The engineers of the Project are working to find a resolution to these pipeline conflicts.

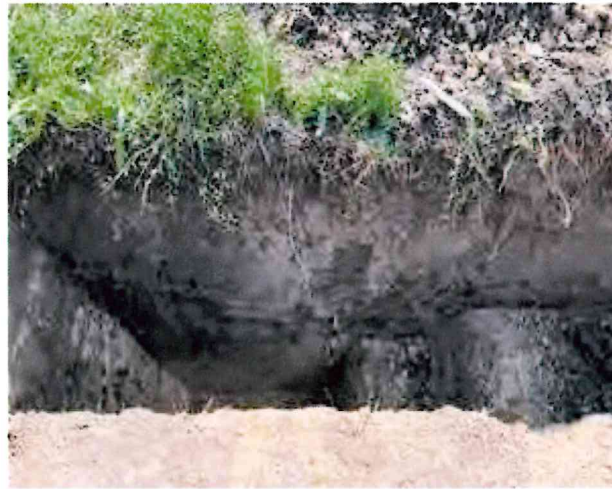
Figure 7-92. View of Trench unit 31.

The site was identified through mechanical trench testing within the APE. The initial trench, Trench 31, tested positive for cultural materials discovered in screening between 150-175 cmbs. A shell fragment and six pieces of lithic debitage were present within a compact silt (10YR 6/4) layer, beneath a dense layer of clay in Trench 31 (Figure 7-92).

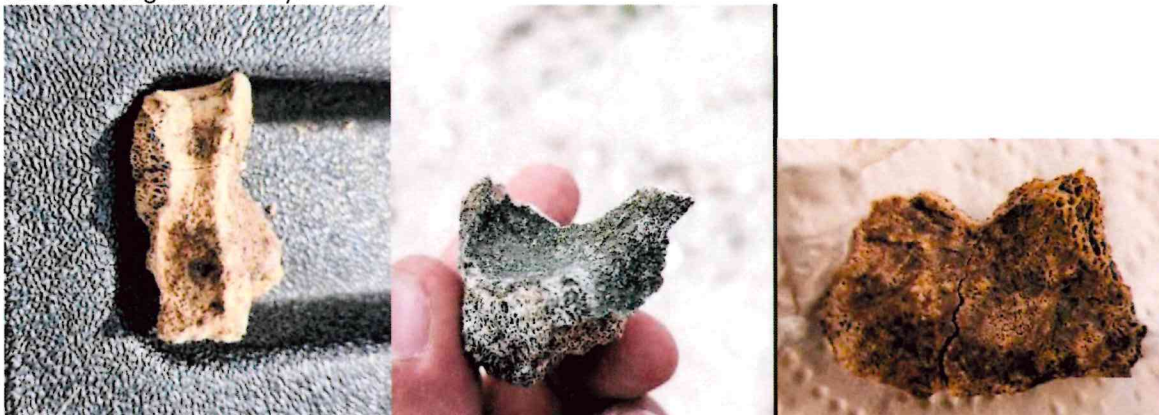
Following the excavation and reburial of Trench 31, degraded bones were observed near the surface of the soil within the backfilled trench. There was no indication that the bones came from the trench, the digging was monitored, and every third bucket was screened, and they were not found during screening or excavation. They were most likely located on the surface of the ground when trenching began and became buried in the back fill pile. When the unit was backfilled, the bones were redeposited on the top layer with the backfill soil. These bones were collected, photographed, and identified as fragments of the tibial, proximal radius, and skull fragments (including a horn base) of a large ungulate, such as deer or cattle, (Figure 7-93) by zooarchaeologists on staff at PaleoWest. The bones did not appear to have any indications of butchery. The crew observed the skeletal remains of several animals (deer, cow) along the ROW during the survey.

Figure 7-93. Overview of a few of the bones found on surface of backfilled Trench 31. Identified as ungulate bone fragments.

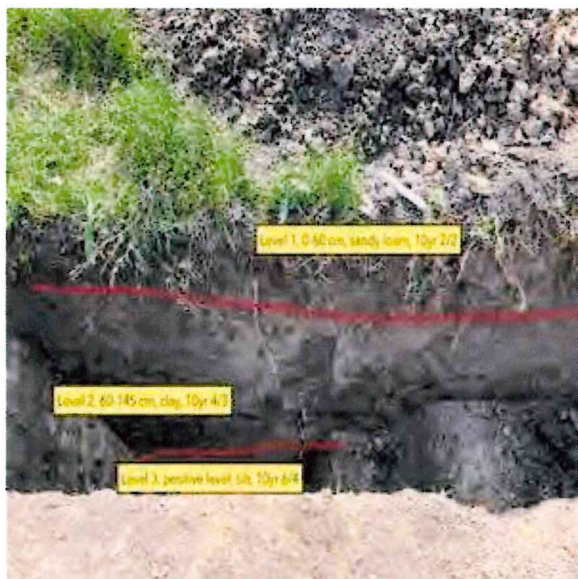
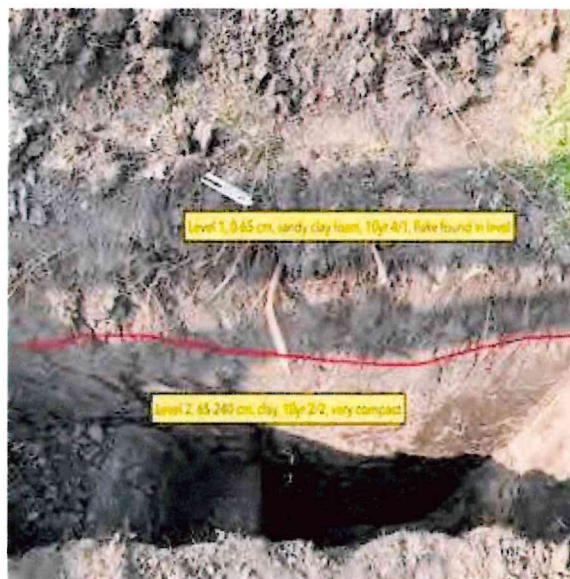
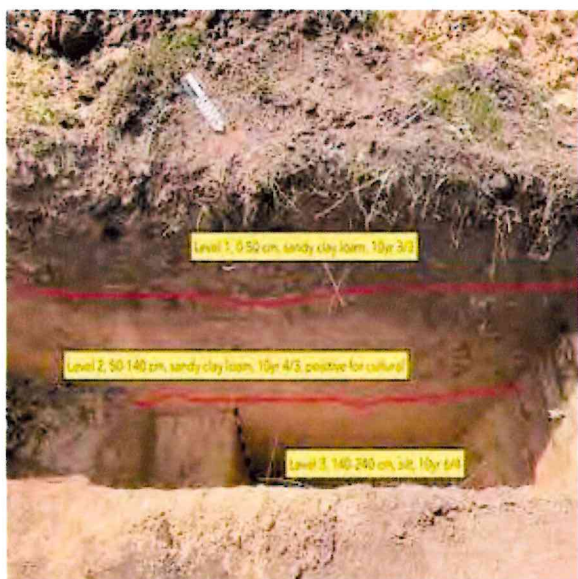
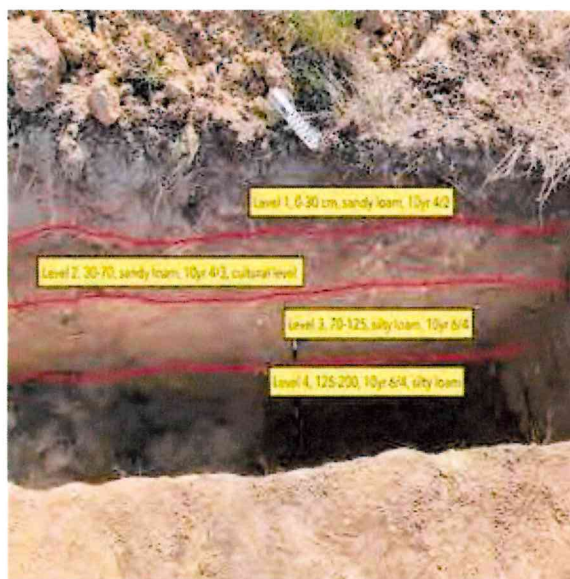
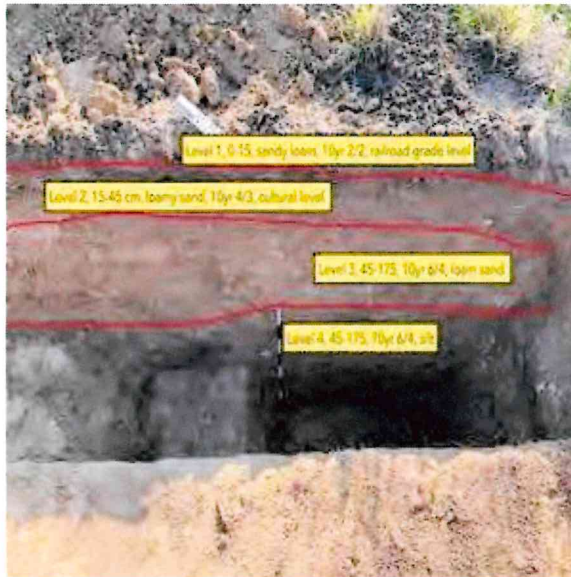
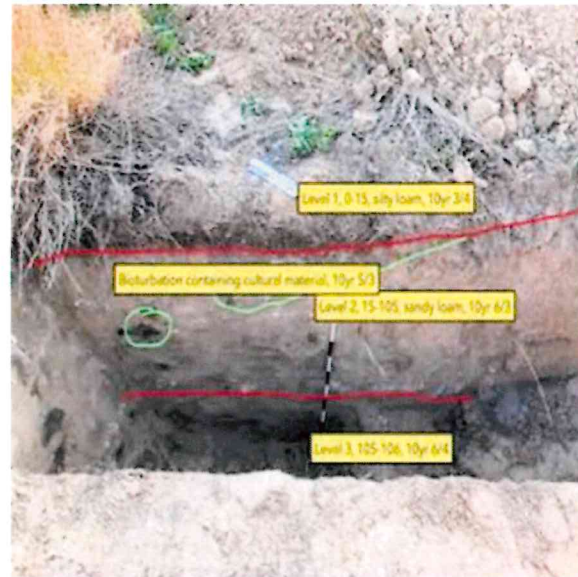
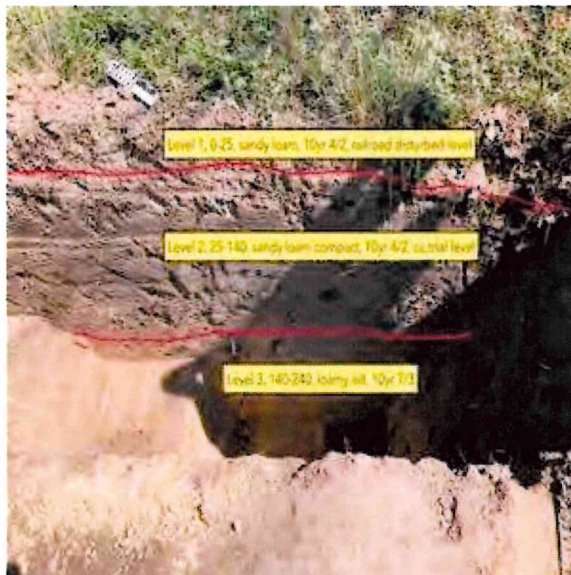
Figure 7-114. Overview of Trench 31, facing southwest.

Figure 7-115. Overview of Trench 31A, facing southwest.

Figure 7-116. Overview of Trench 31C, facing southwest.

Figure 7-117. Overview of Trench 31D, facing southwest.

Figure 7-118. Overview of Trench 31E, facing southwest.

Figure 7-119. Overview of Trench 31F.

Figure 7-120. Overview of Trench 31G.

Seven additional radial trenches (Trenches 31 A-G) and one shovel test were excavated to delineate the site within the APE. Six of the trenches were positive for cultural material, containing shell and debitage (Table 7-4, Figures 7-94 through 7-113). Overall, the most common artifacts were shell fragments, petrified wood debitage, and chert debitage. Debitage of quartzite and chalcedony were also present. These materials were found within similar sedimentary deposits that ranged in depth from 15-140 cmbs across the site (Figures 114- Figure 120).

After delineation testing, the site is present to the southeast of Trench 31A within the APE. Trenches to the southeast discovered substantially more clay deposits than seen in Trench 31A and 31B. Trenching further to the southeast demonstrated that much of that overlaying clay sediment had been removed by previous construction or never present at all. The cultural layer was present at 50-140 cmbs in Trench 31C and at 30-70 cmbs in Trench 31D as the landform rose away from the creek. However, less of the cultural layer was present further to the southeast, along the path of the RR grade. Within Trench 31E, the cultural layer is being between 15-45 cmbs. Within Trench 31F, the cultural layer is virtually absent due in large part

to the work done on the RR tracks. This was further demonstrated with a negative shovel test to the southeast of Trench 31F along the path of the RR grade.
